## Environmental Condition Analysis of the Adjacent Area of Mawa Ferry Ghat, Munshiganj: Findings from a Field Study

Nirupam Deb<sup>1\*</sup>

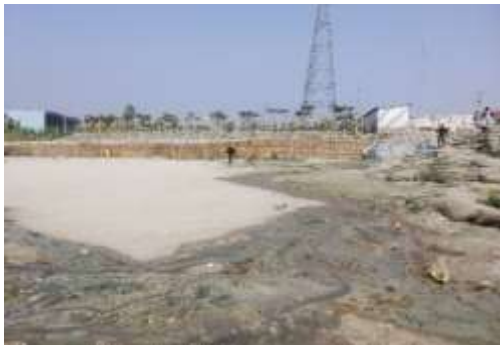
(a) River embankment

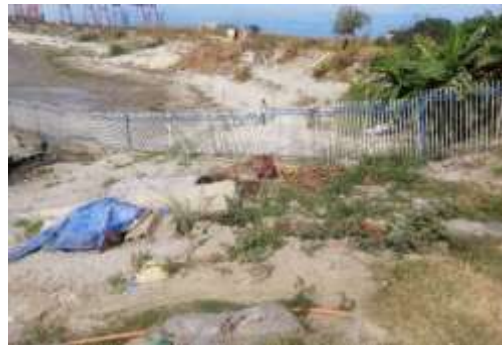
(b) Collapsed by riverbank erosion

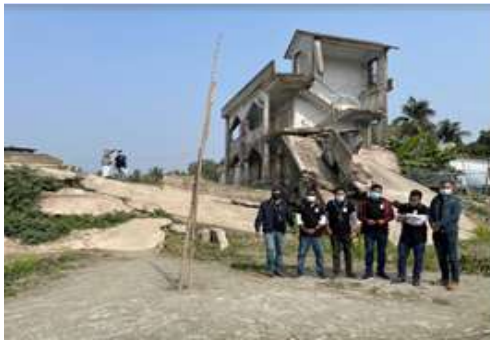
(c) Collapsed by riverbank erosion

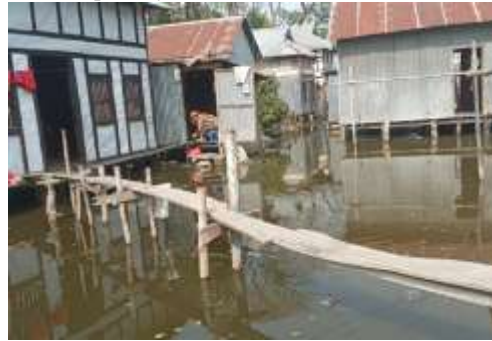
(d) Stagnant water

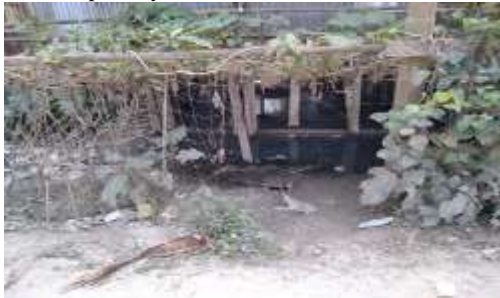
(e) Stagnant black water

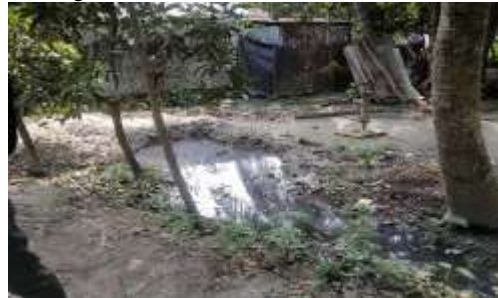
(f) Poor drainage system

- ☑ Drains in the studied Padma bridge resettlement area (RS-08) must have covers to eliminate odors, and drainage of stagnant water is vital to prevent mosquito breeding. Direct connection of septic tanks and trash dumping in drains must be stopped. The drainage network of the studied area needs to be extended because the absence of an adequate drainage system at Mawa Government Primary School and Bepari Bazaar results in massive water blockage.

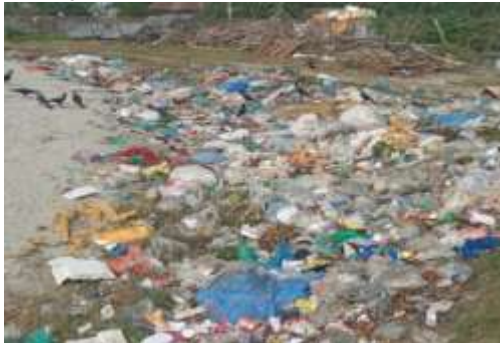
(g) Mismanagement of waste

- ☑ Unsanitary management of waste and wastewater is one of the major causes of environmental degradation observed in the old ferry ghat, adjacent to Shopner Tajmohol restaurant, adjacent to no 3 ferry ghat, Shimulia ferry ghat area, adjacent to the central mosque at the Padma bridge resettlement area (RS-08), adjacent to the east Rampura Mosque Road and adjacent to the Padma bridge stake yard's backside gate. Without efficient waste and wastewater management, living in a healthy environment is a nightmare. Landfills and water treatment plants absent in the studied area are primarily required for successful waste and wastewater management. Public awareness and proper planning are also critical for sanitized waste and wastewater management.

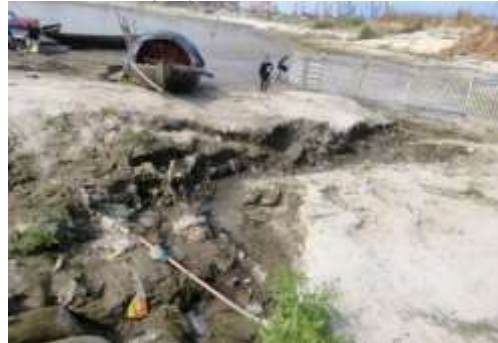
(h) Mismanagement of wastewater
