## Environmental Condition Analysis of the Adjacent Area of Mawa Ferry Ghat, Munshiganj: Findings from a Field Study

Nirupam Deb<sup>1\*</sup>

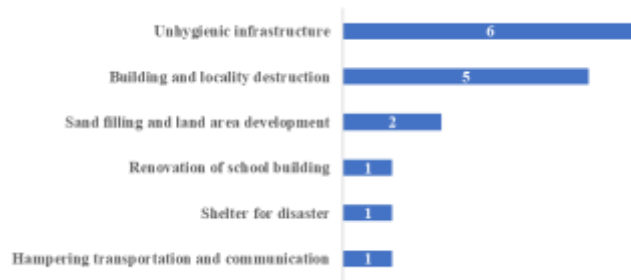
**Fig. 4:** Infrastructure.

According to figure 03, sixteen of the fifty-five observations, or 29%, were classified as infrastructure. Though the research area primarily encompasses many components of the Padma multipurpose bridge project's resettlement zone, it is relatively common for infrastructure to be the most frequently observed feature. The six observations of unhygienic infrastructure in figure 04 tell the story of the unhygienic toilet, drainage, waste, clogged drains, stagnant water beneath a building causing odor and aiding mosquito breeding, and an unhygienic tube well due to the proximity of a pit latrine. Five infrastructure observations of building and locality destruction describe the residents' relocation of nearly three kilometers and the destruction of the Kumarpara Union Parishad building, the old Shimulia-Nurani Madrasah, and the Bhaour Government Primary School building. Two observations documented the resort's construction and land expansion with sand filling. The Bhaour Government Primary School building was renovated; the No. 9 Shimulia Ghat Government Primary School building was used as a shelter during floods; and road connection was hampered by waterlogging, as the last three infrastructure features noted.

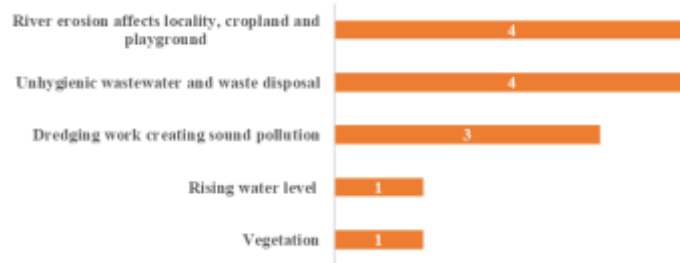
**Fig. 5:** River.

The research location is on the north bank of the Padma, and the feature "river" takes second place with 13 points and 24% of the 55 observation points in figure 03. Figure 05 has a total of 04 points indicating that river erosion has impacted around 14 villages, including Bhaour, Ranigaon, and Ghoria, destroying farmland and playgrounds in Khorla. The following four observations were made about open drainage of untreated wastewater into the river and uncontrolled disposal of solid garbage. Additionally, three observations identified dredging work with heavy equipment at Trawler Ghat, Shimulia, to clear the channel without taking any measures about noise pollution. The last two observations were made about the river's water level rise and vegetation with hyacinths.

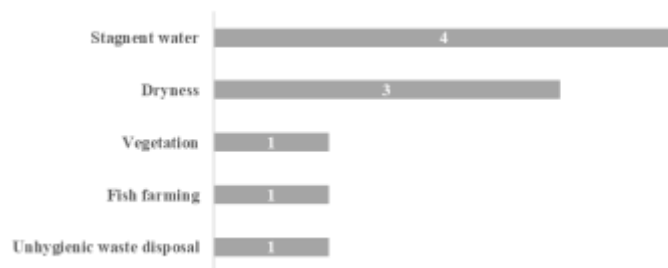
**Fig. 6:** Waterbody.

According to figure 03, 18% of observations were classified as waterbodies. Among these ten points of the waterbody, the first four discuss the blockage caused by artificial barriers and disturbances in the water navigation system; an improper water navigation system results in approximately two acres of land being submerged, and the absence of an adequate drainage system at Mawa Government Primary School and Bepari Bazaar results in massive water blockage.

Following that, the dryness of the waterbody creates flora and fauna's extinction; a water channel dried up despite its connection to the Padma, as described in 03 sites of figure 06. The last three-item concern vegetation with hyacinths, fish farming, and uncontrolled open dumping of solid waste.

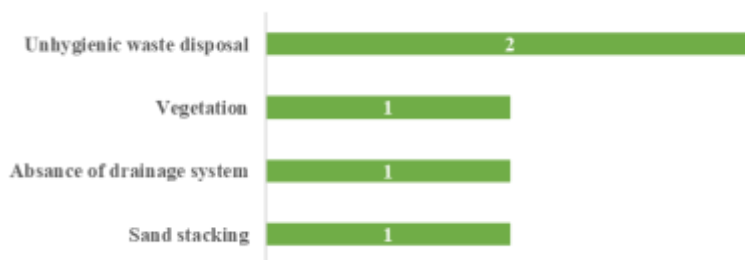
Fig. 8: Wetland.

Five wetland elements in figure 08 illustrate how low-lying land with uncontrolled waste disposal, diverse vegetation cover, a lack of a drainage system, and sand stacking degrade the wetland.

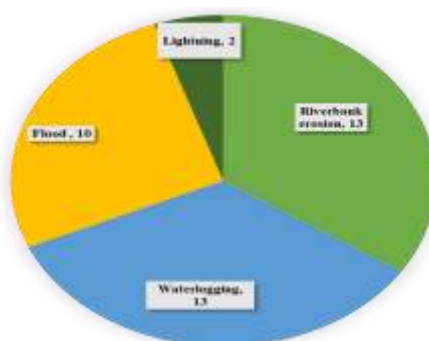
Fig. 10: Identified potential natural hazards.

According to figure 10, riverbank erosion occurred in 13 locations, resulting in the displacement of residents; the collapse of the Kumarpara Union Parishad and Bhaour Government Primary School; the demolition of the west Shimulia local market, and 14 villages, including Bhaour, Ranigaon, and Ghoria; the destruction of the Khorla playground; and the damage of the riverbank resulted in demolished concrete waste.

The following 13 observations of waterlogging in figure 10 include: stagnant water caused by sedimentation behind the stake yard of the Padma multipurpose bridge project; low land, high precipitation, and an inefficient water navigation system; debris and waste; soil contamination; water contamination; mosquito breeding; foul odor; water channel is overgrown with hyacinths; and road connectivity is severely hampered due to waterlogging in the field study area.

Flood is the third natural hazard identified in the research area, with ten citations in figure 10. The absence of a drainage system results in the Padma's water level rise, which destroys many crops, properties, and roads and submerges approximately 2 acres of

land. In addition, the severe uneven settlement of various reinforced cement concrete-made structures along the riverfront in Shimulia ferry ghat area, Wari Bazaar, and along the river in Khorla all contribute to citing the flood as a potential natural hazard. The final natural hazard detected in the research region is lightning, which was documented twice in figure 10. Unfortunately, the network pole near the riverfront, opposite the BIWTA office in the resettlement area, Shimulia, does not have any lightning arrestor.

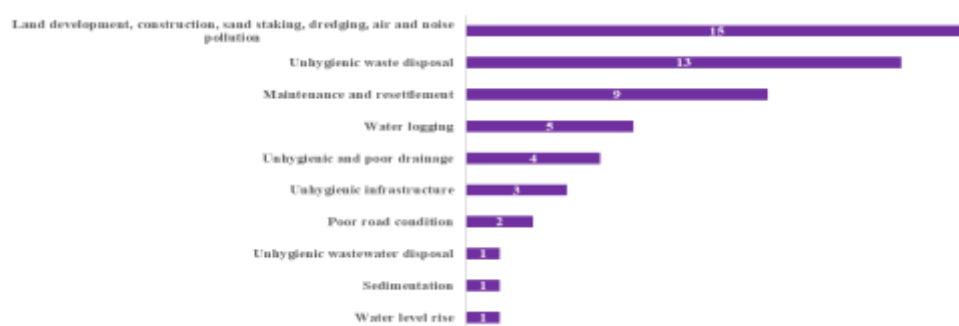
**Fig.11:** Identified environmental conditions.

**Environmental Conditions Analysis:** The 15 sites associated with construction, development, dredging, sand staking, and air and noise pollution account for 28% of the 54 observations in figure 11. For land development purposes, cropland and ditch areas have been reduced and filled with dredged and lifted sand. The land development process is relatively regular on the East Shimulia resettlement project, next to the Mouch sluice gate, the Amena Hakim Madrasah, and Jelepara. Additionally, dredged sand has been staked in front of the network pole near the riverfront, opposite the BIWTA office in Shimulia's resettlement area, alongside the east Rampura mosque road in west Shimulia, alongside the west Shimulia Modhyapara Central Mosque Road, and adjacent to the new Shimulia Ghat area. Without protective measures, such as covering, this massive sand staking operation could result in significant air pollution. Increased dust particle concentration in the atmosphere affects air quality. As this sand is dredged and the byproduct of this phenomenon is sound pollution, there is no mechanism to control it. Additionally, sand lifting contributes to sand staking, which has a detrimental effect on riverfront communities. Furthermore, the new development of many hotels along the Mawa Ferry Ghat and Shimulia ghat roads and a brick manufacturing factory in East Shimulia may result in environmental degradation due to improper landscape planning practices such as waste dumping unhygienically.

Unhygienic waste dumping was cited in old ferry ghat, no 3 ferry ghat, and Shimulia ferry ghat. Beside the east Rampura Mosque Road in the west Shimulia resettlement project and adjacent to Shopner Tajmohol restaurant, and in the China resettlement project, unhygienic waste dumping was also found. Additionally, massive industrial garbage was disposed of near the Padma bridge stake yard's backside gate, such as demolished pieces of reinforced concrete structures. Thirteen unsanitary waste disposal sites accounted for 24% of the 54 observations in figure 11. Moreover, domestic solid waste clogs drain in the China resettlement project area, resulting in a two-acre waterlogging scenario. Additionally, the roadside open waste disposal beside east Rampura Mosque Road in the west Shimulia resettlement project led to various animals devouring the waste particles.

Maintenance and resettlement were accounted for 09 observations in figure 11. Riverbank erosion damaged around 14 villages, including Bhaour, Ranigaon, Ghorla, Kumarpara Union Parishad, East Shimulia Government Primary School, Bhaour Government Primary School, and the playground in Khorla, east Shimulia. These demolished facilities must be relocated and restored. The road network in Khorla, ward 03, Shimulia, has also been destroyed and requires reconstruction. Additionally, certain spots in west Shimulia require road diversion.

The five observations of waterlogging in figure 11 depict a complicated scenario of odorous, black-colored, and aesthetically objectionable stagnant water adjacent to the "Ajgor Mia" house in the west Shimulia resettlement project, as well as stagnant water alongside the Padma bridge casting yard fence. This stagnant water is an ideal breeding ground for mosquitoes that transmit malaria. In addition, road connectivity is likely to be significantly harmed due to waterlogging in east Shimulia. Moreover, waterlogging harms the infrastructure in east Shimulia.

In figure 11, four unhygienic and poor drainage instances accounted for 7% of the 54 observations. In the Shimulia ferry ghat area and Padma bridge resettlement area (RS-08), west Shimulia, poor drainage, direct septic tank connection, blockage due to lack of lid, and trash dumping in drains were noted. Due to the lack of a drainage system in Mawa Government Primary School, Bepari Bazaar, a large amount of water has become clogged. These unsanitary conditions and inadequate drainage can result in malaria, as stagnant water is a familiar mosquito breeding source. Odor is also a regular and unavoidable occurrence due to unsanitary structures.

Three unhygienic infrastructures were identified, accounting for 6% of the 54 observations in figure 11. First, the existing plinth level of the production tube well in front of the central mosque at the Padma bridge resettlement area (RS-08) is not paved, resulting in water pollution. Additionally, the unsanitary toilets found in Wari, tube well, and a pit latrine coexisting in the Shimulia ferry ghat neighborhood may pose health risks, such as diarrhea or cholera. Two locations with poor road conditions have been found in Jelepara, east Shimulia. These two points illustrate how the sand lifting pipe crosses the local road, causing

inconvenience to patients, pregnant women, and senior citizens and the danger of slope failure due to poor compaction during construction.

According to figure 11, sedimentation obstructs water passage behind the Padma bridge's stake yard (near fishing boat parking). However, one statement depicts untreated wastewater being discharged directly into the river near No 3 Ferry Ghat. Lastly, one location in Jelepara, east Shimulia, discusses how river training activity alters the direction of water movement or flow, resulting in an undesirable rise in water level. The rise in water levels may cause floods.

- ☑ Unsanitary management of waste and wastewater is one of the major causes of environmental degradation observed in the old ferry ghat, adjacent to Shopner Tajmohol restaurant, adjacent to no 3 ferry ghat, Shimulia ferry ghat area, adjacent to the central mosque at the Padma bridge resettlement area (RS-08), adjacent to the east Rampura Mosque Road and adjacent to the Padma bridge stake yard's backside gate. Without efficient waste and wastewater management, living in a healthy environment is a nightmare. Landfills and water treatment plants absent in the studied area are primarily required for successful waste and wastewater management. Public awareness and proper planning are also critical for sanitized waste and wastewater management.

- ☑ Cropland and ditch areas have been reduced in the East Shimulia resettlement project, next to the Mouch sluice gate, the Amena Hakim Madrasah, and Jelepura due to land development purposes. Therefore, for efficient watershed management, it is vital to protect mainly ditch and low-lying areas, which store the precipitation. It is also essential to clear existing water navigation channels and remove obstructions to prevent waterlogging, the second most identified natural hazard in the study area.

- ☑ The plinth level of tube wells in front of the central mosque at the Padma bridge resettlement area (RS-08) must be paved to reduce health hazards such as diarrhea and cholera, And the toilets need to be made more hygienic. Besides, public awareness is also crucial in this regard.

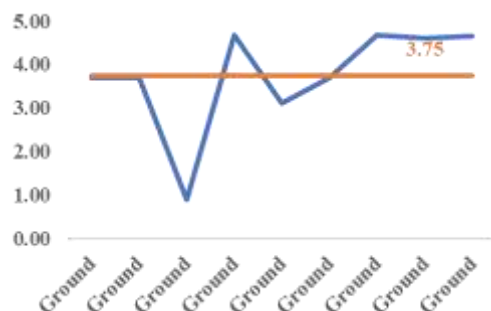
Fig. 15: Dissolved Oxygen (DO) test results of groundwater sample.

The dissolved oxygen (DO) concentration of the 09 groundwater samples ranged from 0.90 mg/L to 4.67 mg/L, with a mean of 3.75 mg/L. The standard deviation was therefore calculated to be 1.21 mg/L. The mean dissolved oxygen (DO) concentration of the 15 surface water samples was 4.12 mg/L, ranging from 3.20 to 4.68 mg/L. The calculated standard deviation was 0.56 mg/L. Therefore, both coefficients of variation of 0.32 and 0.14  $< 1$  indicate that the distribution of dissolved oxygen (DO) concentration values are adequately centered around the mean value. Thus, both DO mean value above the tolerance range indicates a barely good fit but should not be considered healthy water.
